**Tenmile River Assessment**

Shoreline Survey and Action Plan

February 2006

Tenmile River Stream Team Report

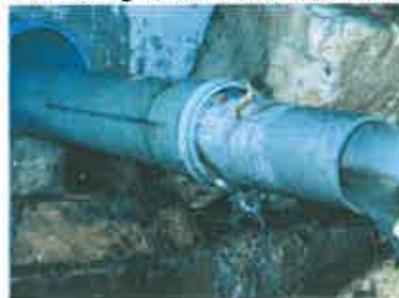
Pipe discharging by Woodwinds

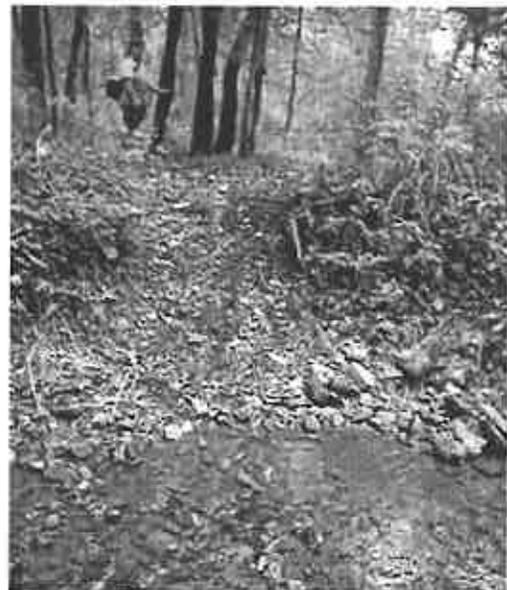
The end of the segment is near a small tributary on State property known as the Wassaic Multiple Use Area. ATV tracks were observed traversing this area and causing negative impacts on the riparian zone and the river.

ATV tracks leading into tributary

- Discourage littering.
- Monitor sewage outlet.
- Encourage railroad to repair riparian zone near tracks
- Educate, monitor and regulate ATV users.

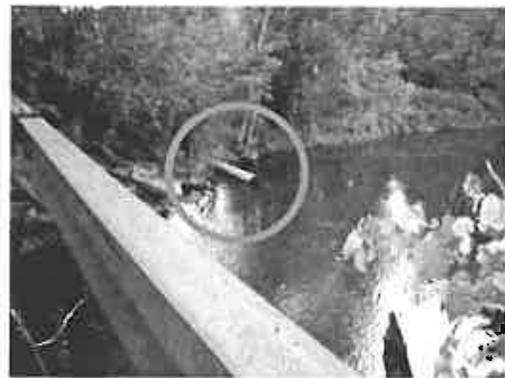
DDSO. It has a large discharge pipe that enters the river near a damaged bridge. which is falling into the river. Litter was common throughout this section.

Discharge pipe by Taconic DDSO

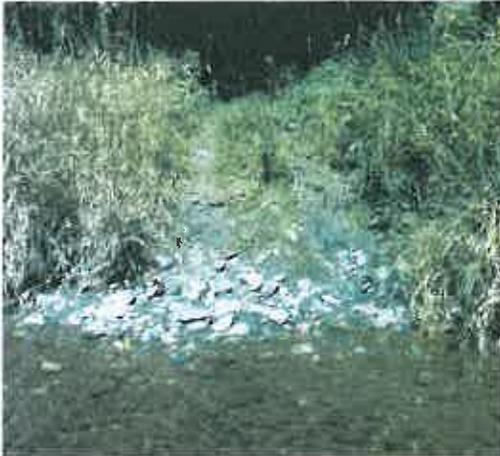
Stream bank stability is threatened in many places by extensive ATV use. This is especially apparent near the end of this segment where Oak Drive allows for easy river access. A motorcycle track and a closed construction-and-demolition site are located near the Oak Drive area. It is evident that motorcyclists ride from the track onto sandbars along the river's edge.

ATV crossing, one of many on the river

- Educate and regulate ATV users.
- Educate homeowners on importance of riparian zone.

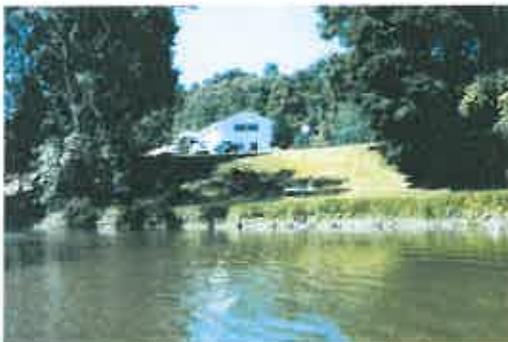
Some homeowners have cleared or mowed their property down to the edge of the river. The riparian zone was seriously compromised in this area. Dumping was also observed, including large items like abandoned cars.

Mowing to the river's edge

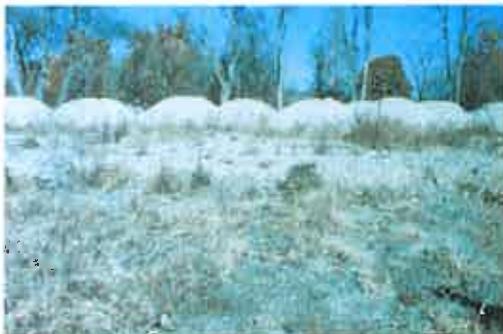
The most serious impairment on the entire river is in this segment. Tennmile River LLC, off of Midfield Lane north of Dover Plains, has covered several acres of this property with construction-and-demolition debris. This has obliterated a wetland and spilled over silt fences down into the river. The debris was tested by the Town of Dover and found to contain mesityl oxide, a compound known to be toxic to aquatic life. This material is leaching into a small stream that leads into the Tennmile. The Town of Dover is currently seeking remediation of this site in order to

Piles of construction and demolition debris along the river's flood plain

- Monitor dumpsites.
- Regulate ATVs.
- Initiate clean-ups.
- Support town efforts to remediate Tenmile River LLC site.

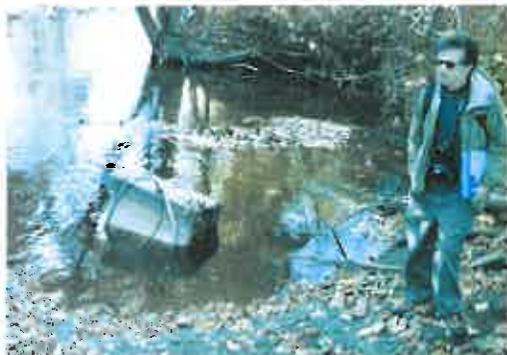
Trash dumped in the river near Dover Plains

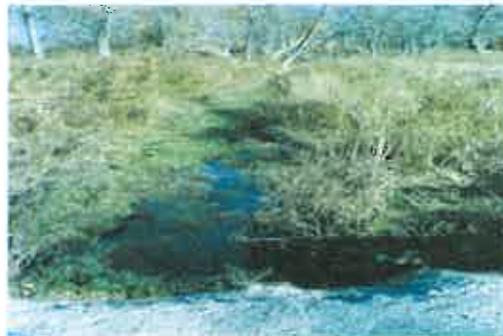
The most severe impairment found along the river is a large illegal construction-and-demolition dump called Tenmile River LLC. The waste, tested by the Town of Dover, was found to contain mesityl oxide, a chemical toxic to aquatic organisms. This site is currently under investigation and enforcement for non-compliance by the New York State Department of Environmental Conservation and the Town of Dover. Two other areas of concern that need further assessment are a dumpsite south of the railroad bridge near the C&D waste site and a pipe located near Westchester Modular Homes that was observed to be discharging a foul odorous white liquid into the river.

Mesityl oxide leaching into Tenmile tributary

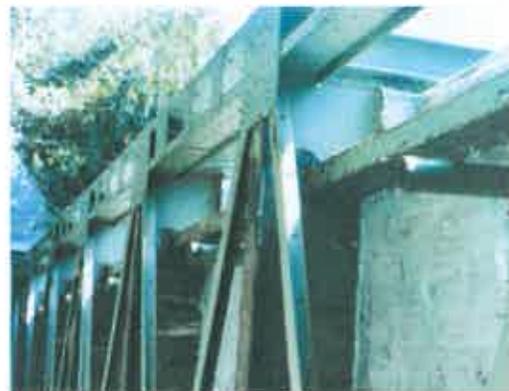
Drains on Limekiln Road Bridge

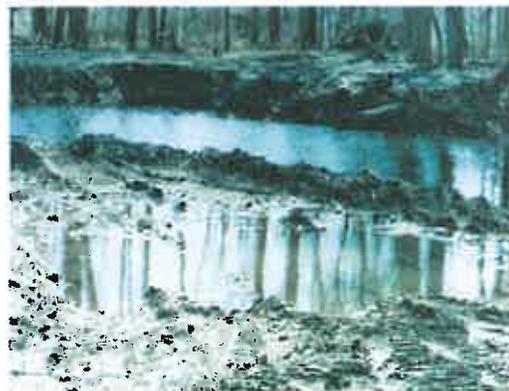
Construction along the Swamp River

- Clean up trash.
- Regulate ATVs.
- Alert DEC and Town government of dumping.
- Pursue cessation of silt and construction deposits with the Town located at the mouth of Swamp River.

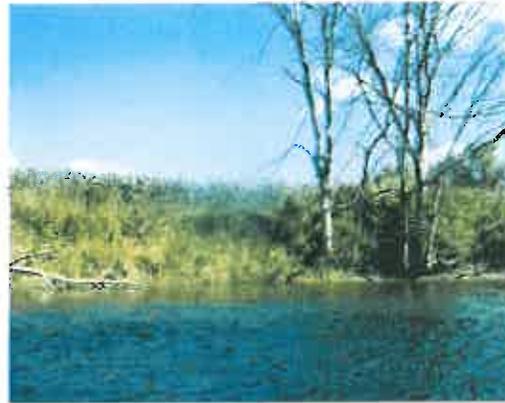
Cornfield close to the river

- Move agricultural zones back from the river.
- Close crossings.
- Restore riparian zone.
- Explore and monitor for lead impacts along the river.

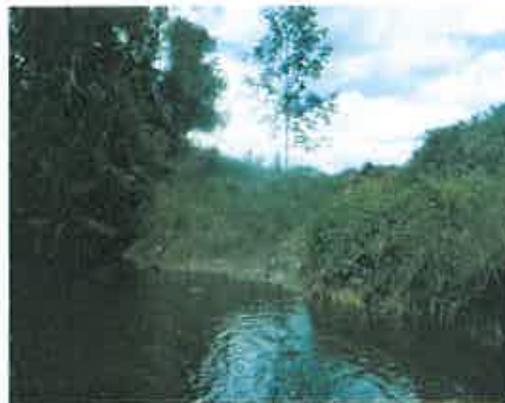
Farm road entering the river

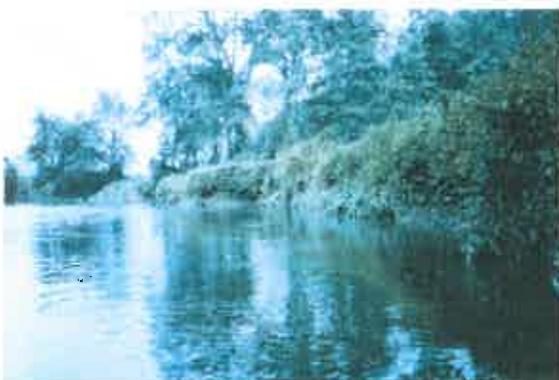
* Invasive plants observed included purple loosestrife, Russian olive, Oriental bittersweet, bush honeysuckle, Eurasian water milfoil, Japanese barberry, knapweed, multi-flora rose and garlic mustard.

Invasive species in riparian zone

- Monitor river for contamination.
- Control invasive species.
- Explore potential of lead contamination.

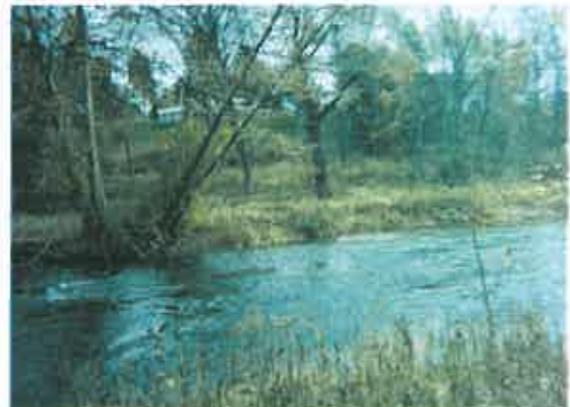
In a few places, homeowners have cut down trees in the riparian zone and have mowed down to the edge of the river. This is a common practice along most of the river and could be remedied by an education program for riparian zone restoration. The cutting is probably to improve the residents' view of the river.

Riparian zone mostly mowed down

- Restore riparian zone.
- Clean up along road.
- Educate homeowners on importance of riparian zones.

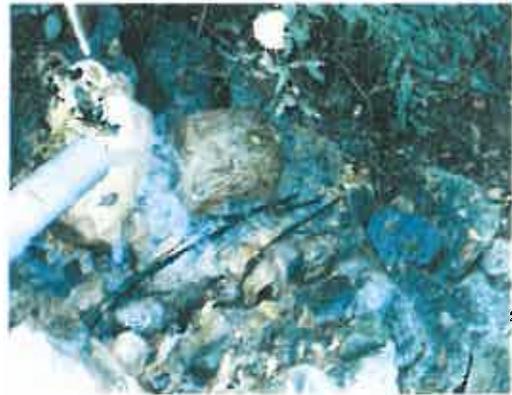
east bank. There is a large buffer zone between the river and these two areas, but a sewage disposal outflow pipe enters the stream at this point. This is a permitted use discharging a significant flow that has been observed to be murky, cloudy and odiferous. In the same area a milky liquid was observed entering the river from below the surface. Its origin was not determined.

Sewer outfall

- Clean up trash.
- Monitor sewer.
- Restore riparian zone.

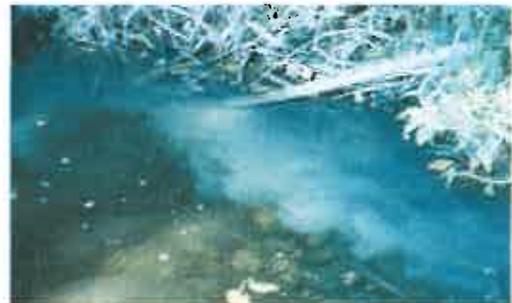
Murky discharge

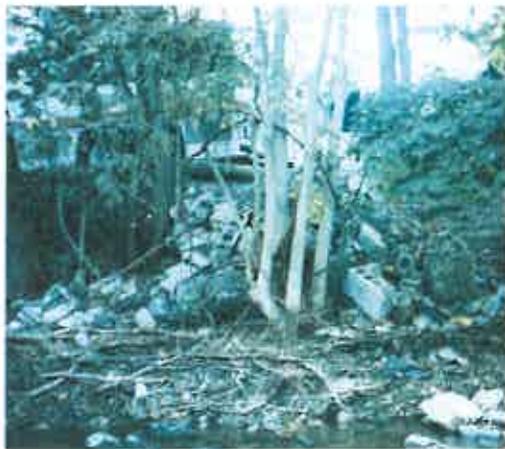
The riparian zone on the western bank has been mowed to the river and a bus garage parking lot impinges on the banks. Litter and debris along with a drainage pipe were found here.

Bus garage and trash
