Appendix 2-A: Site Photographs

Cricket Valley Energy Center LLC
Dover, NY
Site Reconnaissance Photographs
June 1-3, 2009

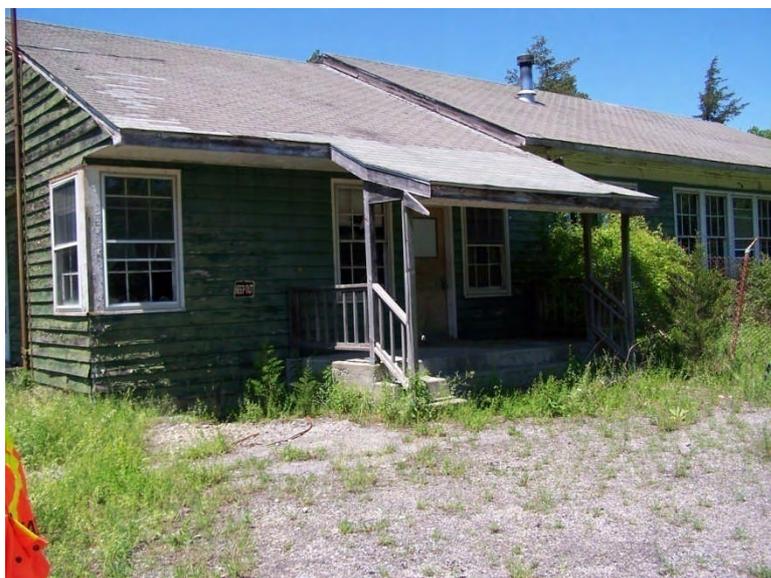
1. Building A – Office

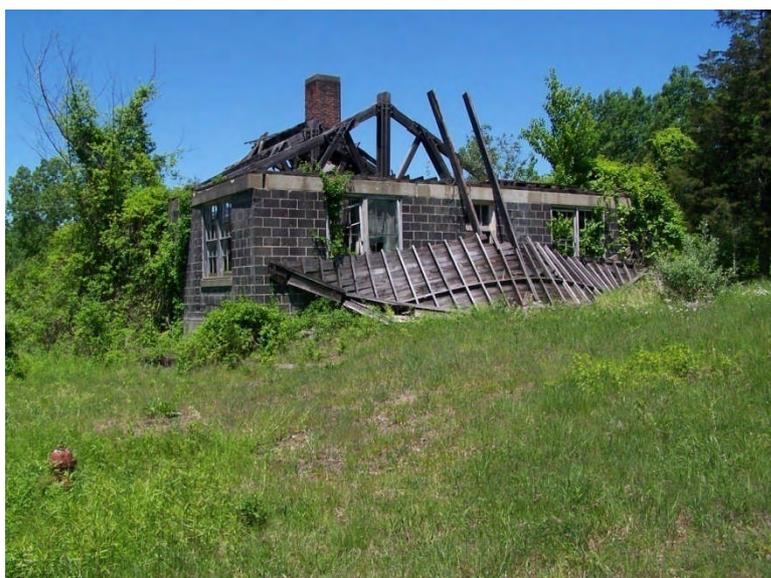
2. Building B

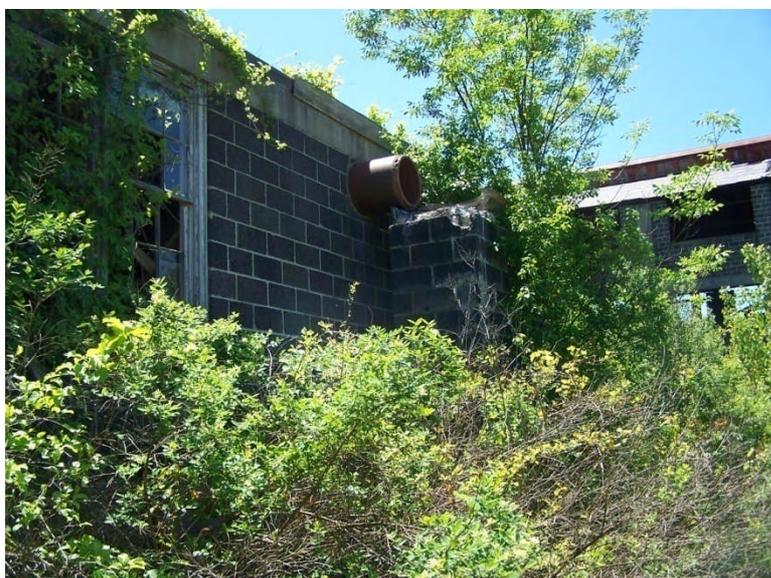
3. Building B and clay pipe near roof

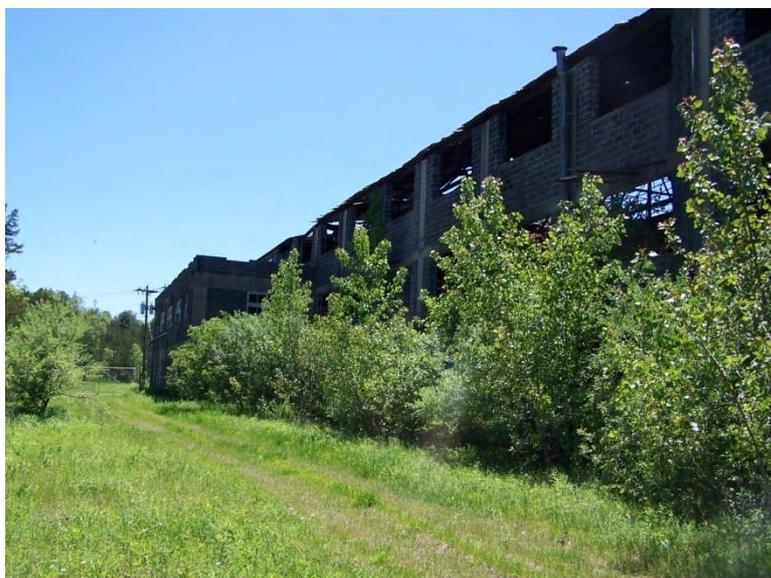
4. Building C (Looking southwest)

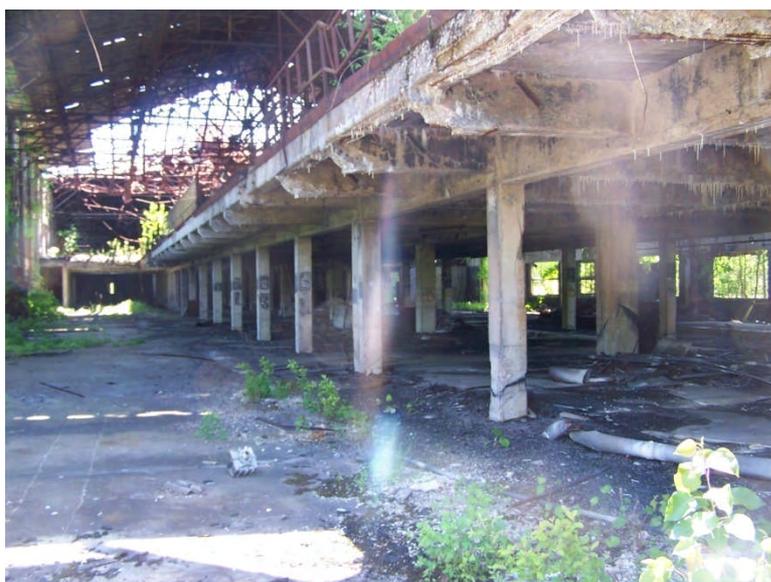
5. Interior of Building C

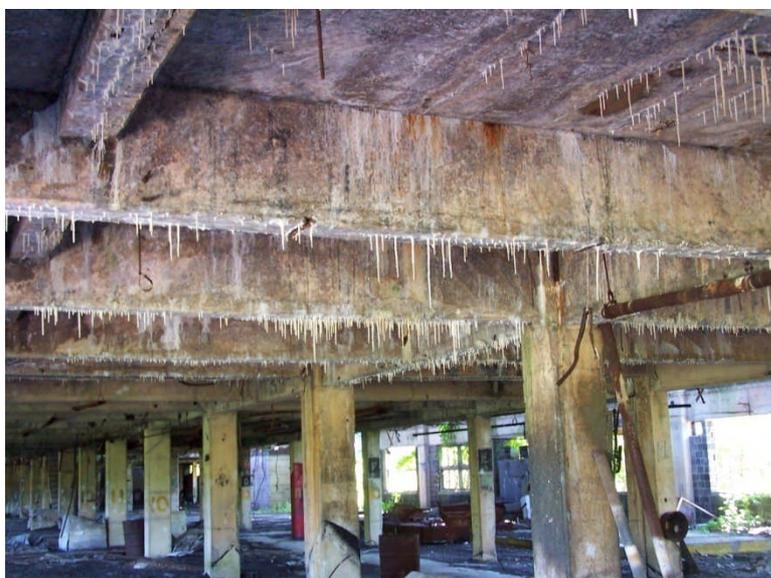
6. Building C first floor and white precipitate

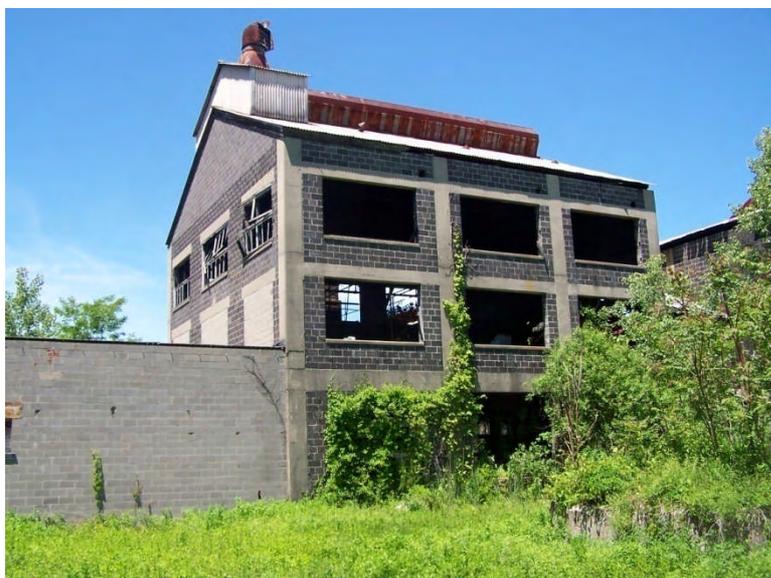
7. Building D (Looking north)

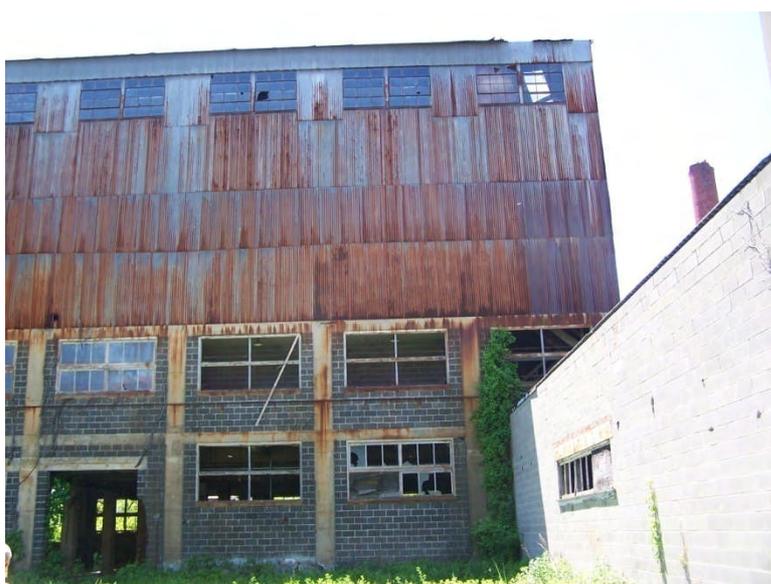
8. Building D (concrete block) and
Building E (northern end)

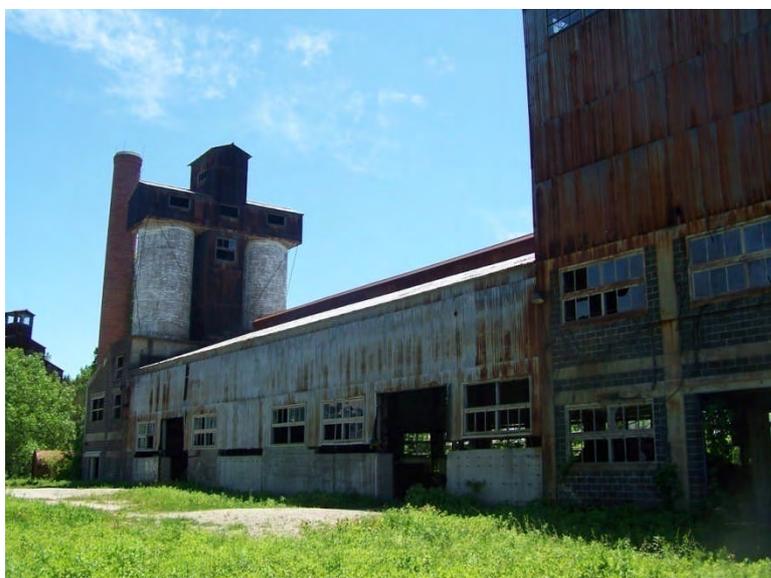
9. Building E (looking south)

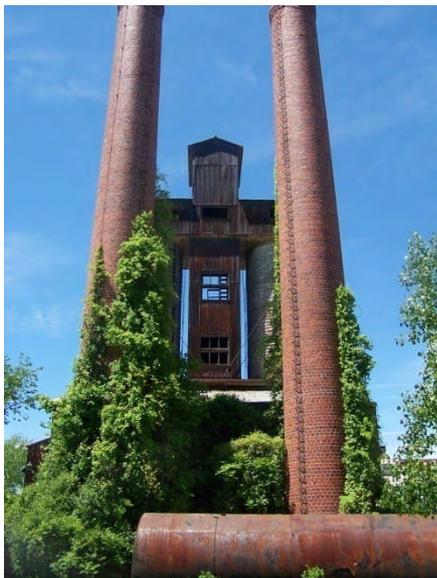
10. Building E (northern end)

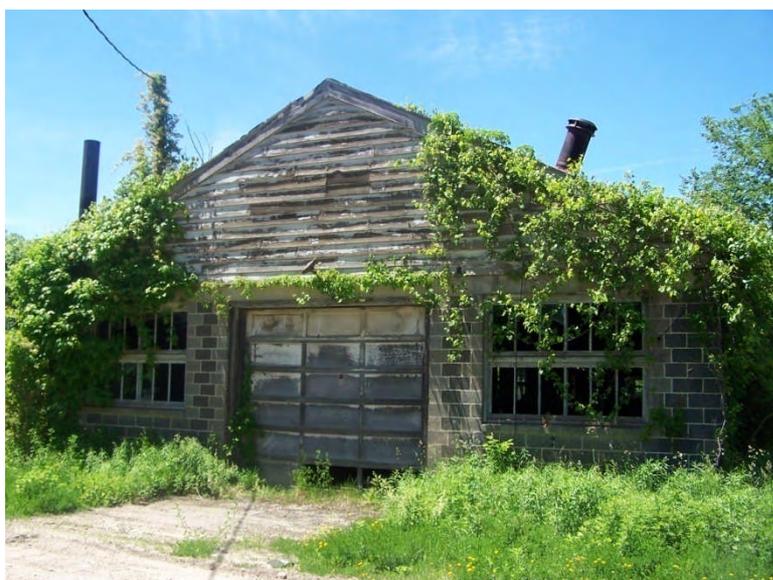
11. Building F (storage building)

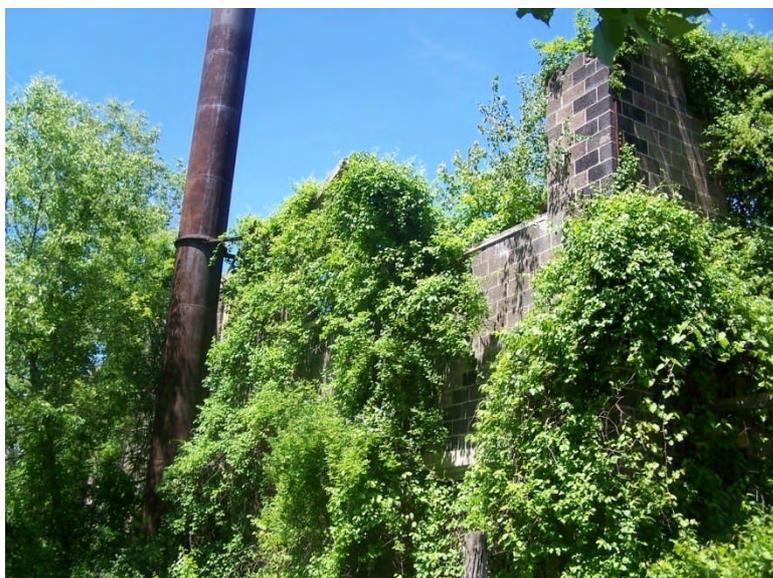
12. Building G (with steel chimney)

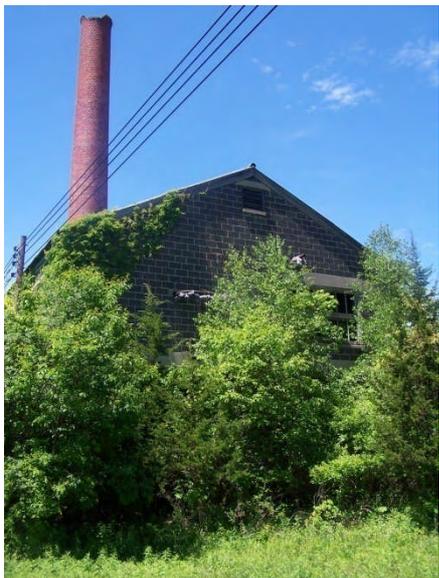
13. Building H (with brick chimney)

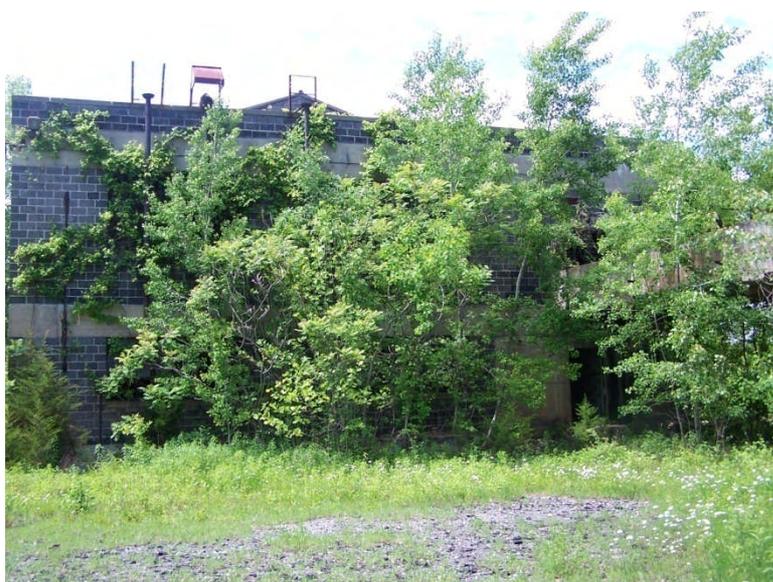
14. Building I

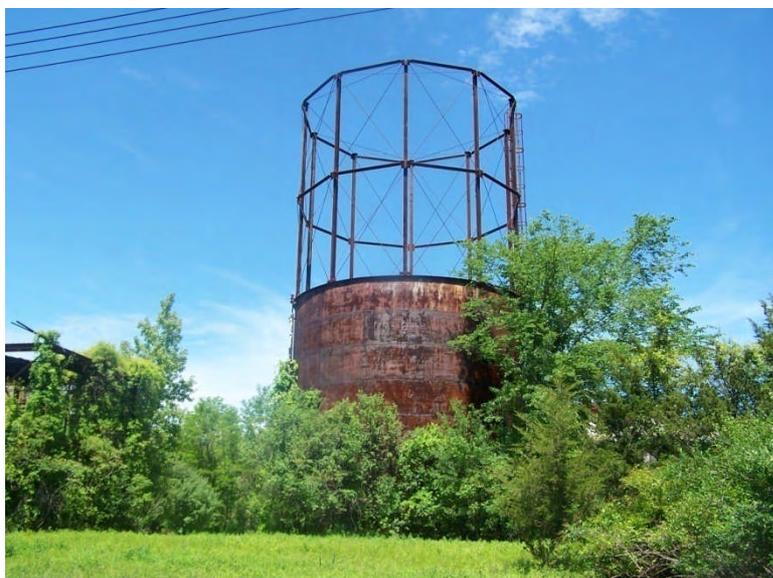
15. Gas Holder

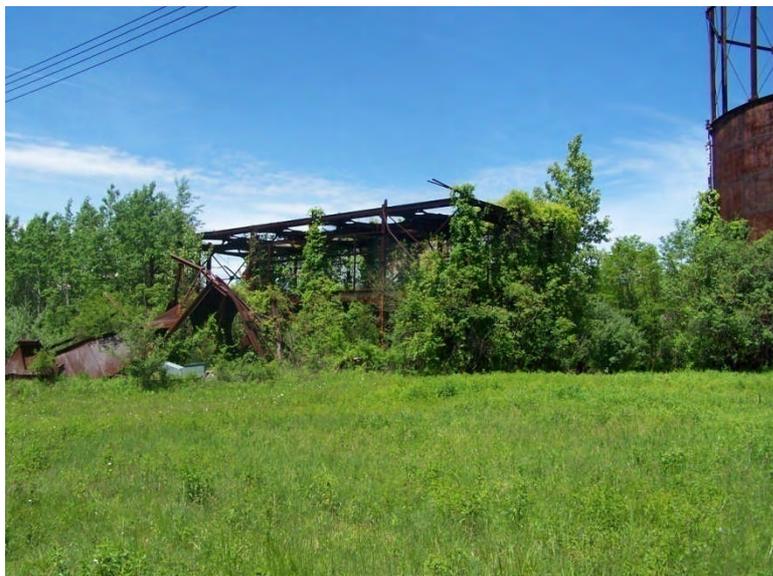
16. Collapsed Steel Building

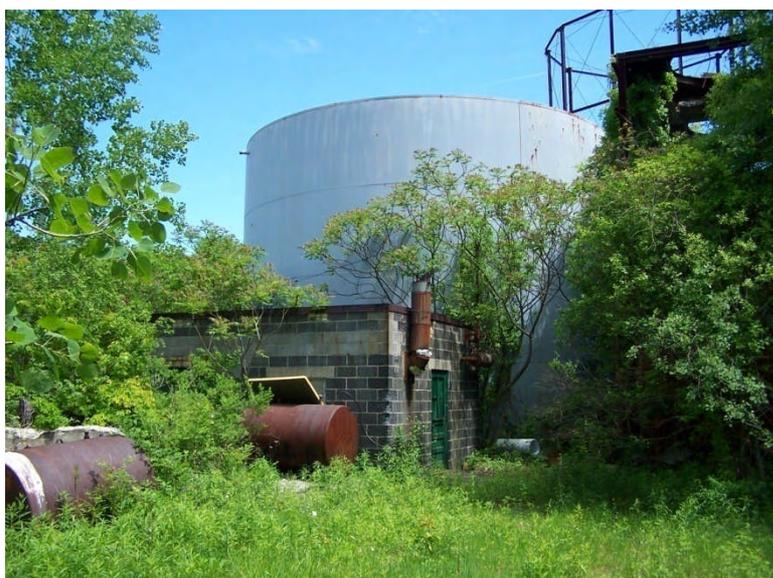
17. Large Storage Tank and associated building

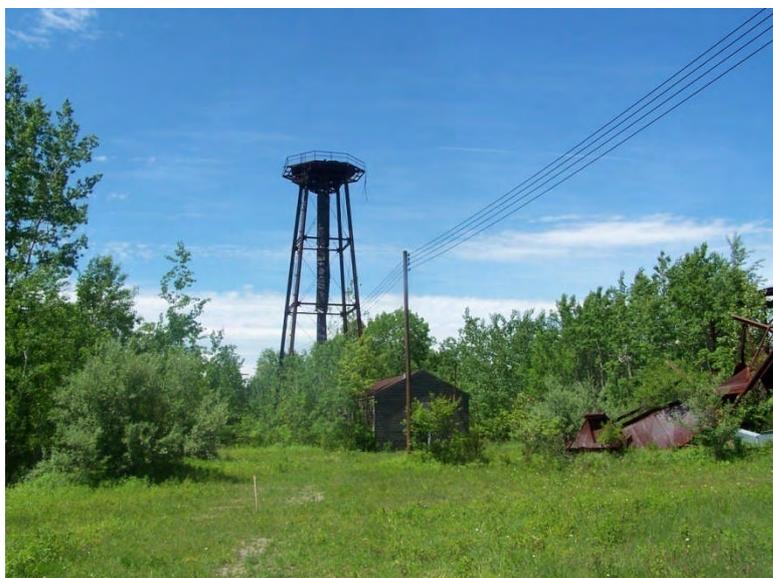
18. Water Tower and associated building

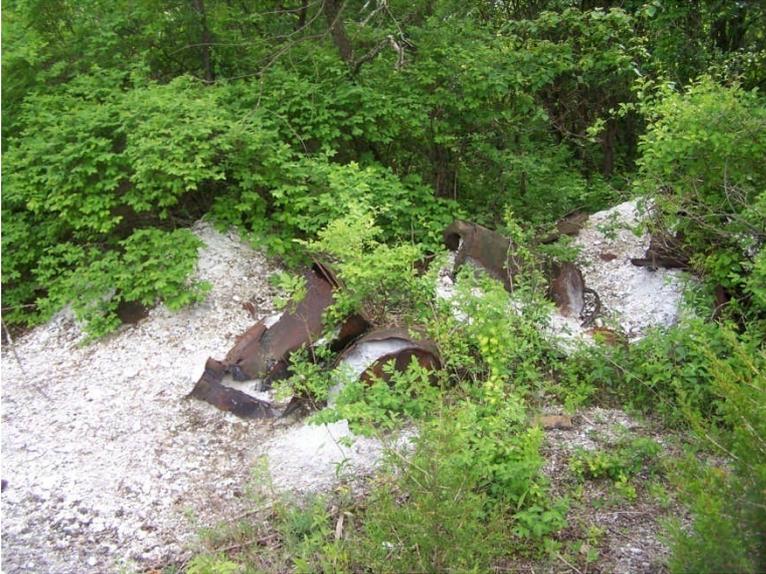
19. Drum and white material disposal near Wetland 2.

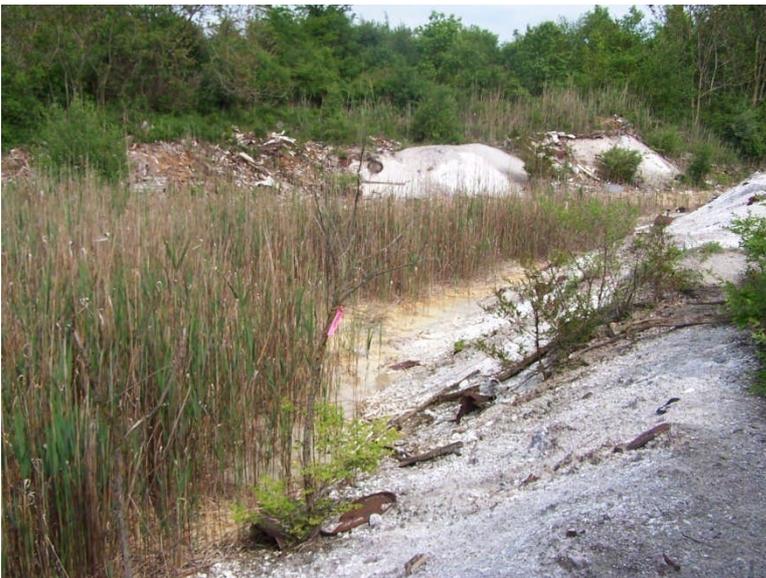
20. Swale and banks leading to Wetland 2.

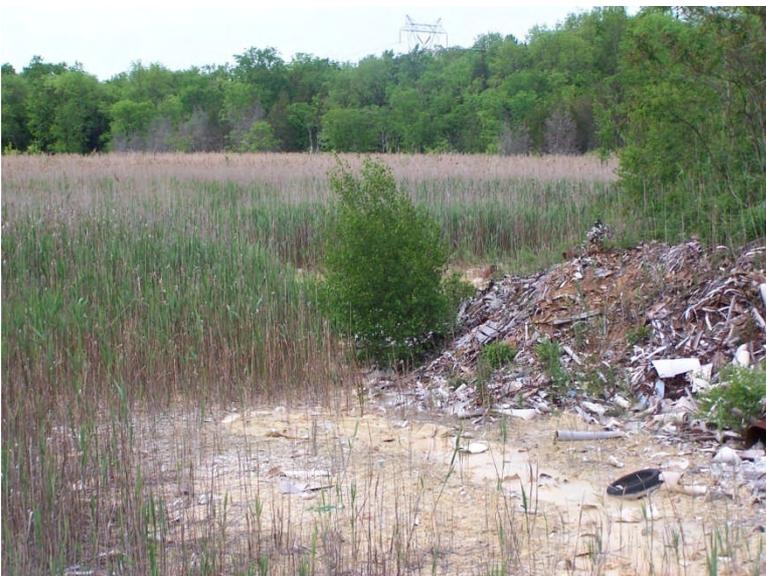
21. Wetland 2, with tan sawdust material visible.

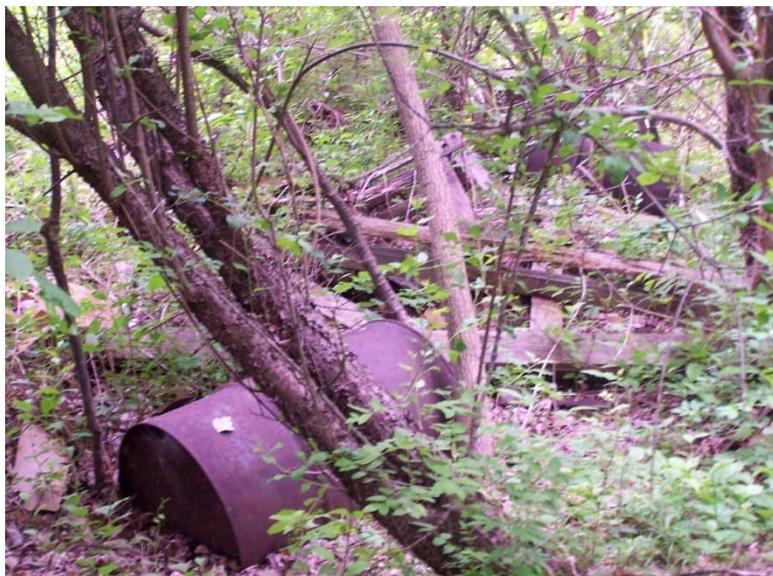
22. Drum and debris near edge of north wetlands.

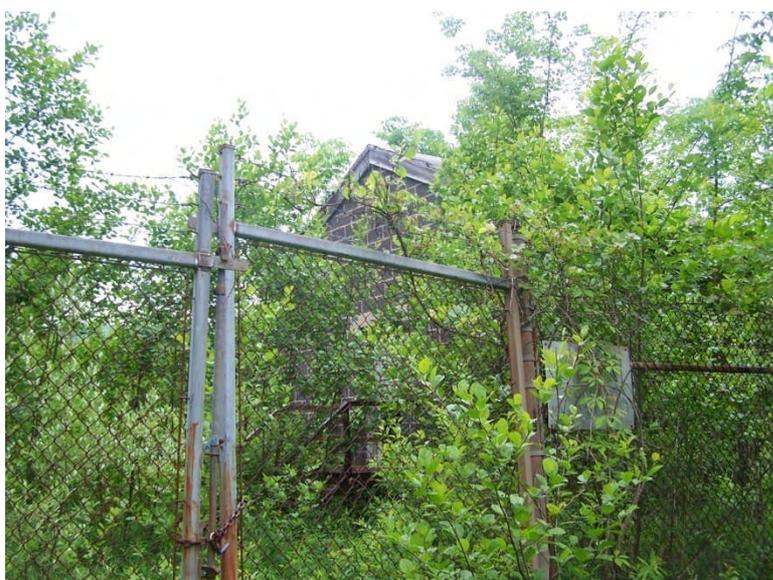
23. Pump station near Swamp River.
