Re: Review of Dover Village Plaza Expansion – Subdivision & Site Plan Approval  
Tax Grid No. 7063-00-562258  
Dover Village – Map No. 10031  
CEA No. 21104

Carpenter Environmental Associates, Inc., (CEA) has reviewed aerial imagery, USGS topographic maps, documents provided by the Town of Dover Planning Board (TDPB) for the construction of a proposed Hannaford Shopping Center, and parts of the New York State Department of Environmental Conservation (NYSDEC) records for the entire 11.9 acre subject property, to evaluate the presence or absence of historical wetlands on the property of the proposed shopping center. CEA has compiled historical aerial imagery, topographic maps, and technical narratives to conclusively demonstrate that a historical wetland that drained to both Seven Wells Brook and Stone Church Brook, NYSDEC Class A & C(t) protected streams, existed on the project site. Furthermore, there is significant evidence to indicate that wetland soils and hydrology still exist on the project site today.<sup>1</sup> CEA offers the following figures and associated comments with respect to historical wetland filling and the potential for wetlands to currently be present on the pr

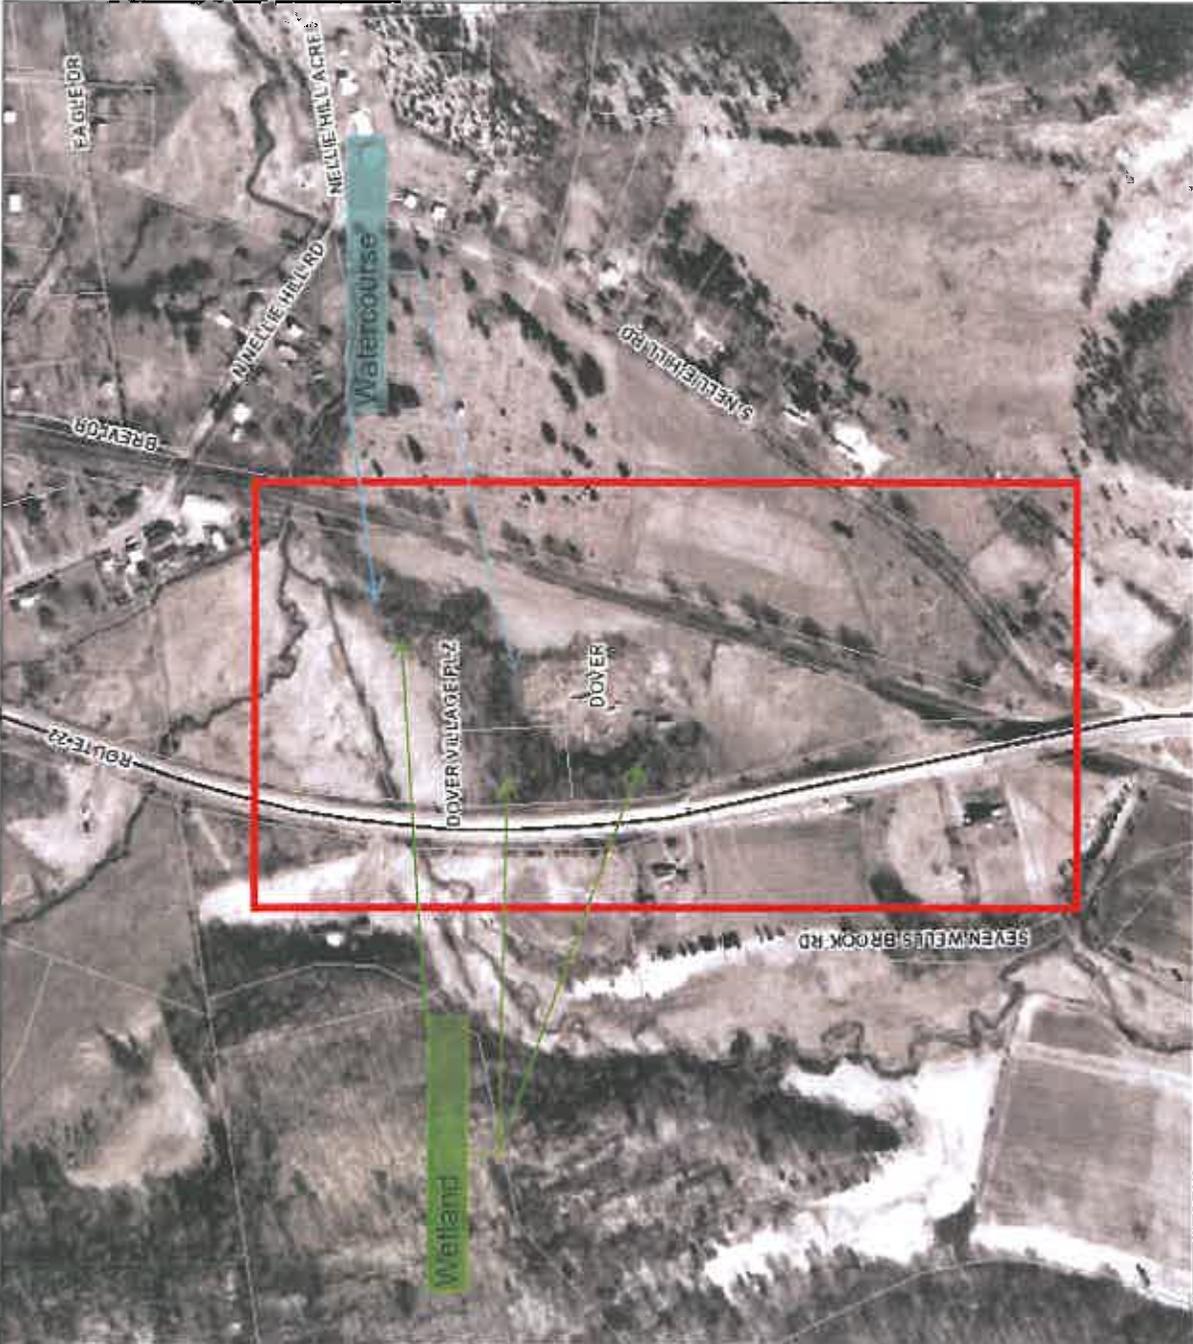
**FIGURE 9**

- The **1970 & 1971 B&W aerial photographs (Figures 9 & 10)** still depict the site as containing wetlands and watercourses that drained to the Seven Wells Brook and Stone Church Brook, NYSDEC Class A & C(t) protected streams respectively.<sup>11</sup> The vegetation is covering approximately 25-30 percent of the site primarily within the wider, northern half of the project site, primarily towards the northwest. The lack of vegetation within the southern tip and the northeastern corner of the parcel continue to indicate some level of historical disturbance. Clearing and/or filling of the southeastern corner of the wetland vegetation as noted in 1948, 1955, 1959, and 1967 is still evident, and has expanded. There is a good amount of activity with trucks or trailers operating within the wetland area. The wetland appears to have less vegetation overall, but the stream channel is still prominent.

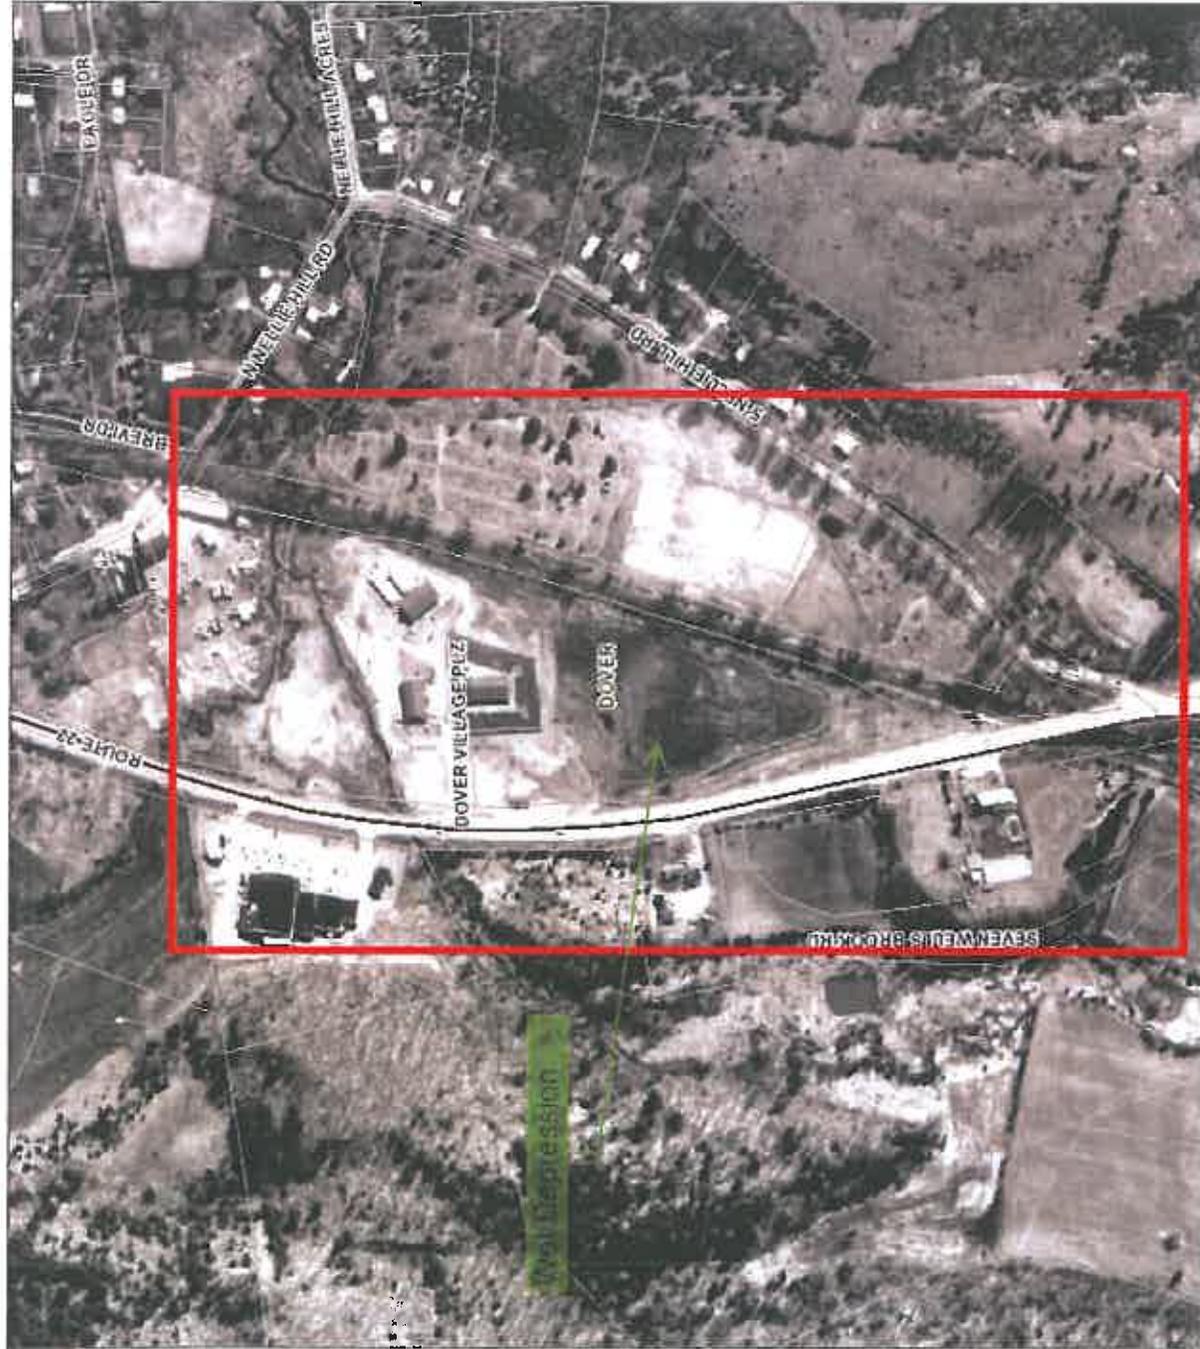
FIGURE 13

- The **1980 and 1981 B&W aerial photographs (Figure 13, 13A & 14)** depict the site as being graded and filled. Construction of the structures that comprise Dover Village Square have begun. Any wetlands or watercourses that drained to the

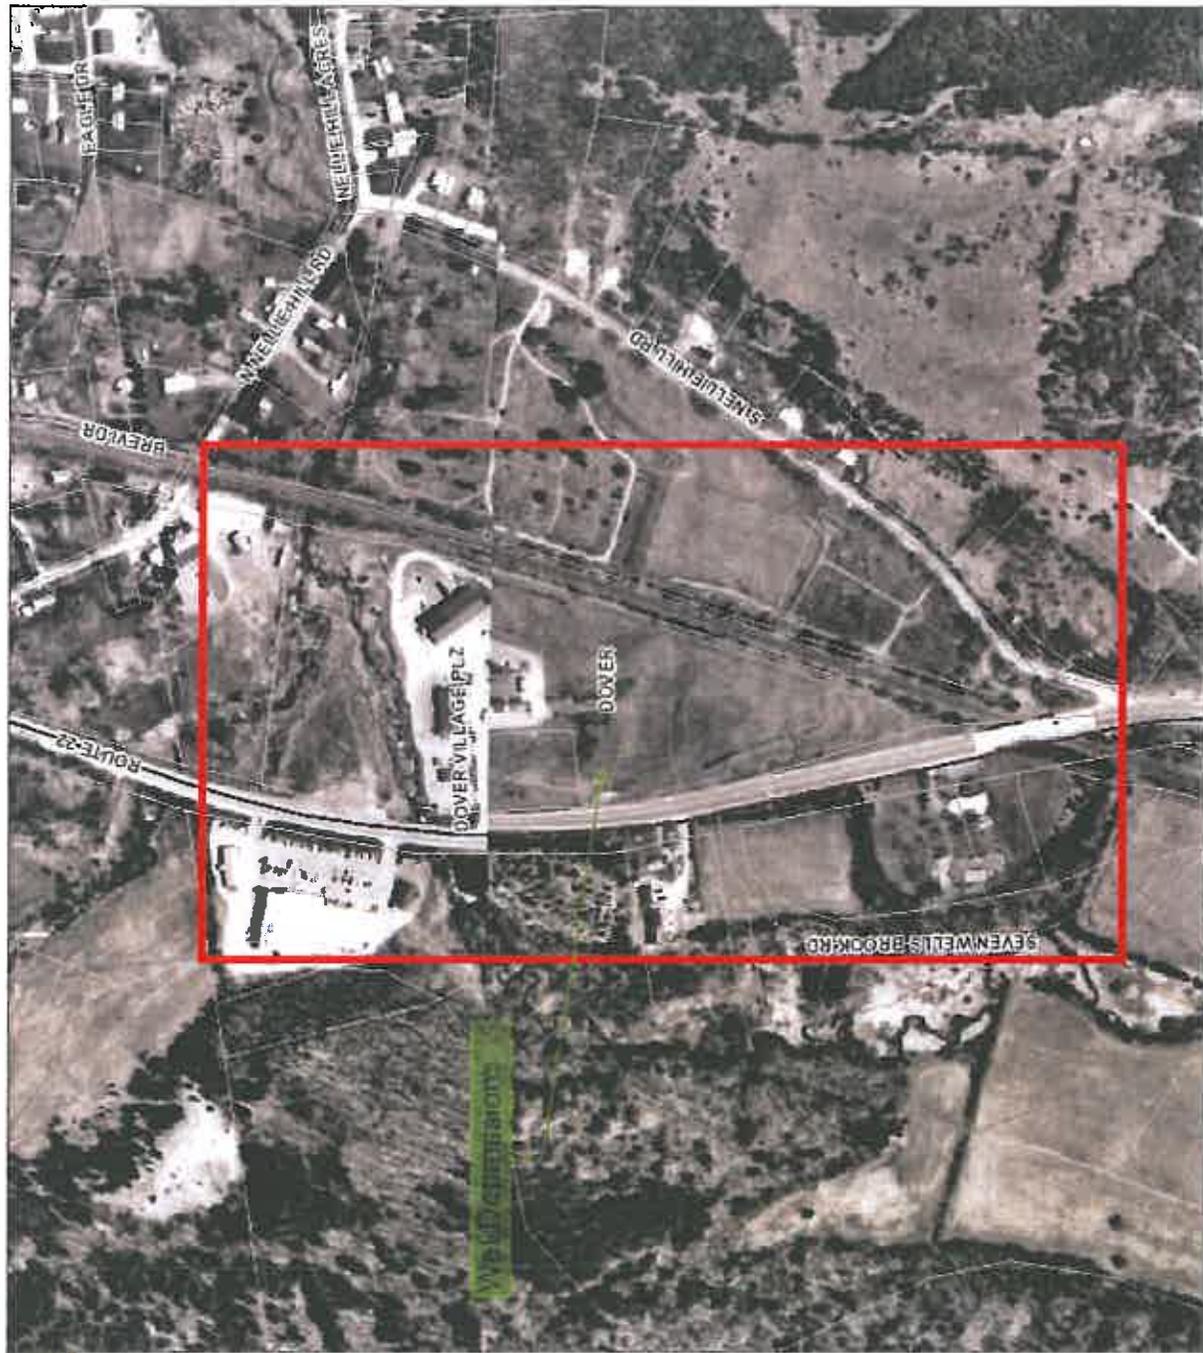
1990  
**FIGURE 17**

- The **1990 B&W aerial photograph (Figure 17)** depicts the structures that comprise Dover Village Square as occupying the northern half of the subject parcel.<sup>18</sup> Immediately south of the developed structures, there is a wet depression. This may indicate that that even though the wetland vegetation was graded, sufficient hydrology and hydric soils still remained.

The remainder of the aerial imagery in Figures 17-23 depicts a large, persistent, wet depression in the exact location of the historic wetland. This area, just south of the current Dover Village Plaza structures, constitutes supporting evidence that both hydrology and potentially hydric soils are still present as components of the wetland system that has been documented both visually (aerial photography) and narratively (NYSDEC reports) for decades on this site.

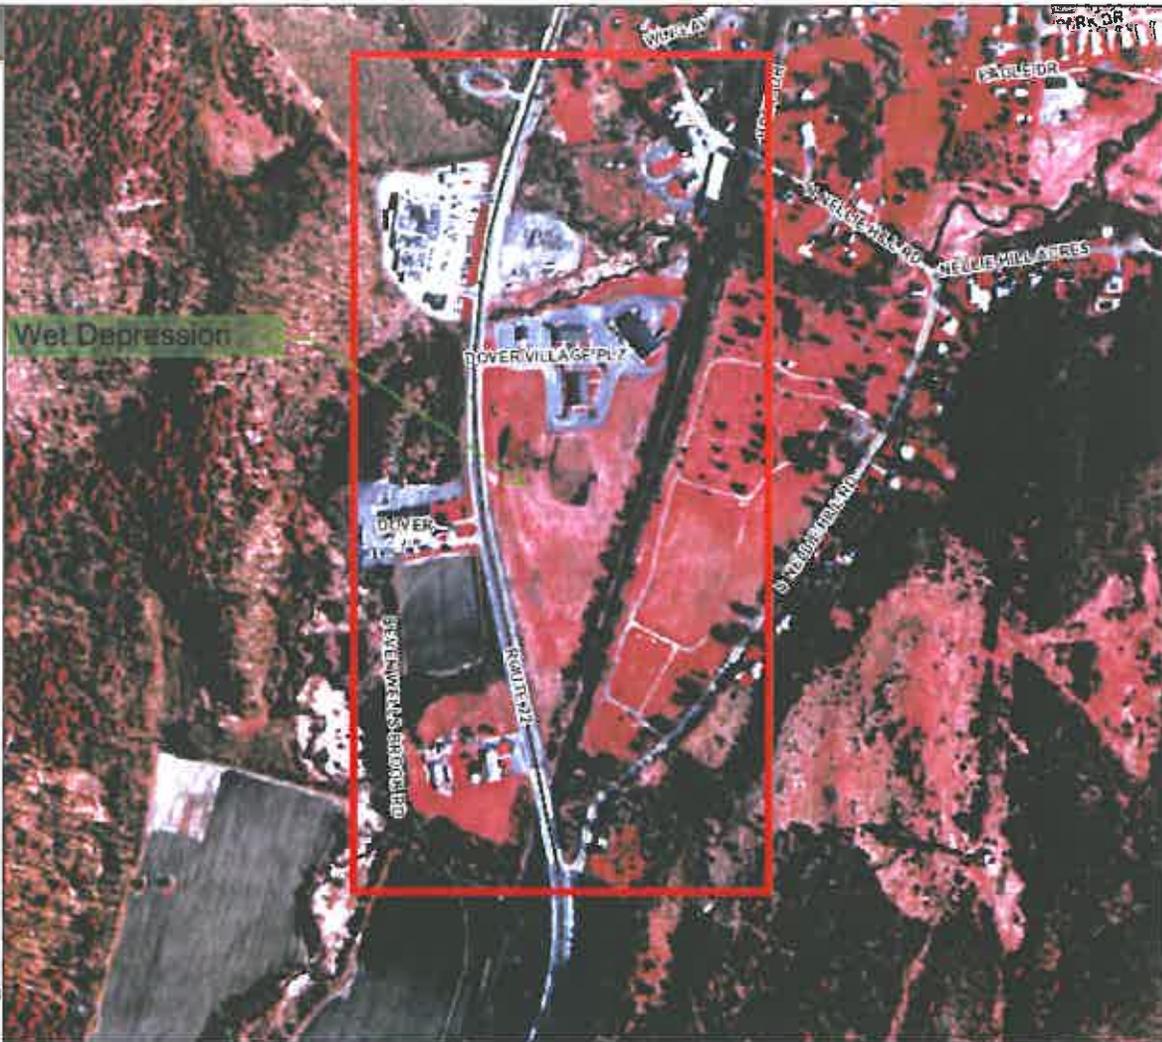
## FIGURE 18

- The **1995 CIR aerial photograph (Figure 18)** depicts the structures that comprise Dover Village Square as occupying the northern half of the subject parcel.<sup>19</sup> Immediately south of the developed structures, there is still a wet depression. This is a strong indicator indicate that that even though the wetland vegetation was graded, sufficient hydrology and hydric soils characteristics still remain. The USGS map from **1998 (Figure 19)** labels approximately 35 percent of the subject property as *marsh or swamp*.<sup>20</sup> The location of the marsh or swamp symbols correlate with the location of the wetland vegetation depicted on the historical aerial photographs as well as the wet depression seen in the 1995 CIR aerial photograph. The structures that comprise Dover Village Square are depicted just north of the marsh or swamp label.

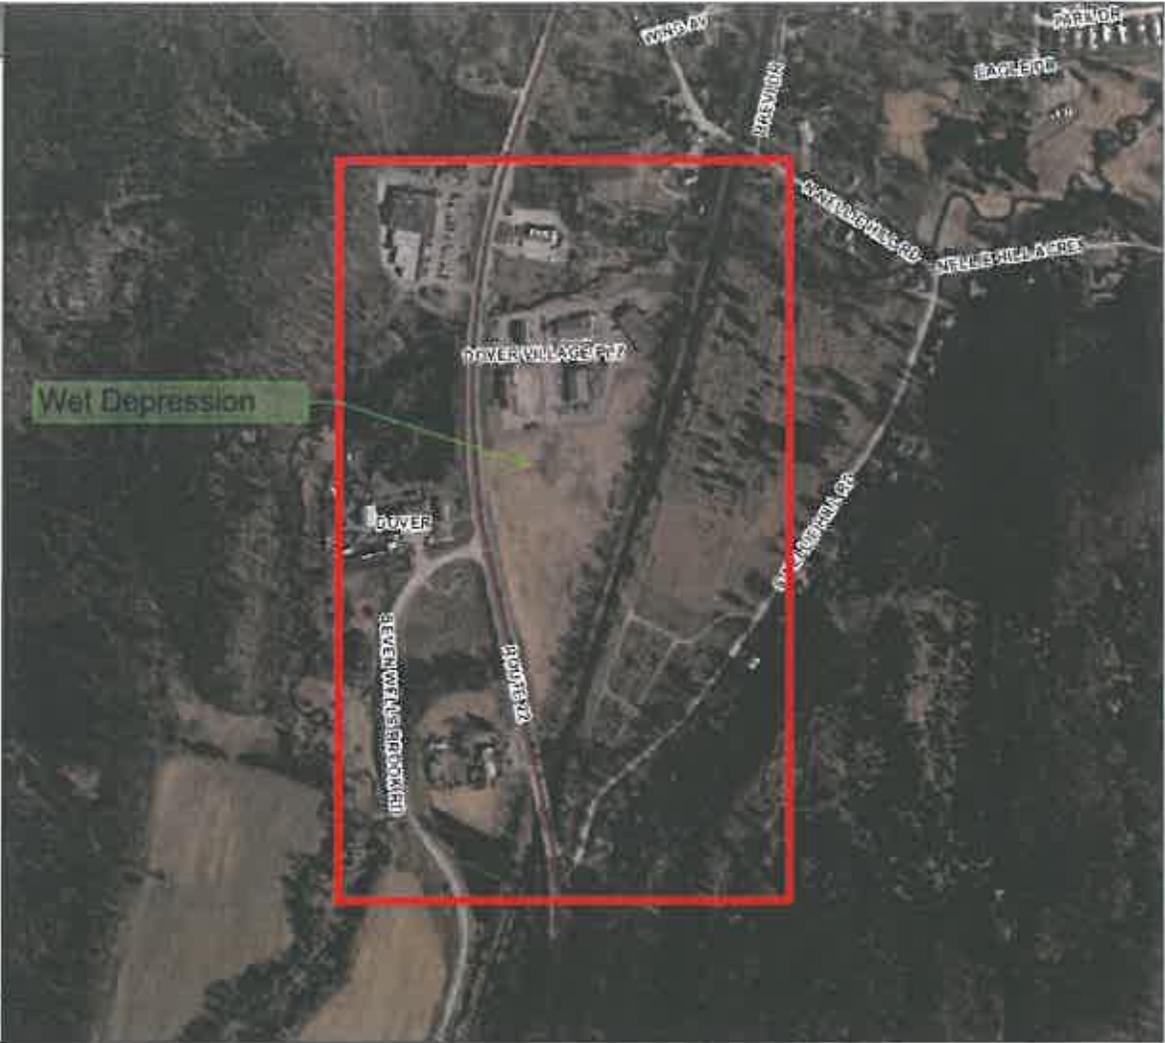
2009  
FIGURE 22

- The **2009** Color aerial photograph (**Figure 22**) depicts the structures that comprise Dover Village Square as occupying the northern half of the subject parcel.<sup>23</sup> Immediately south of the developed structures, there is still a wet depression. Once again, this is a strong indicator indicate that that even though the wetland vegetation was graded, sufficient hydrology and hydric soils characteristics still remain. The USGS map from **2011** (**Figure 23**) labels approximately 35 percent of the subject property as *marsh or swamp*.<sup>24</sup> The location of the marsh or swamp symbols correlate with the location of the wetland vegetation depicted on the historical aerial photographs as well as the wet depression seen in the 2004 and 2009 Color aerial photographs. The structures that comprise Dover Village Square are depicted just north of the marsh or swamp label.
