**Tenmile River Assessment**

Shoreline Survey and Action Plan

February 2006

Tenmile River Stream Team Report

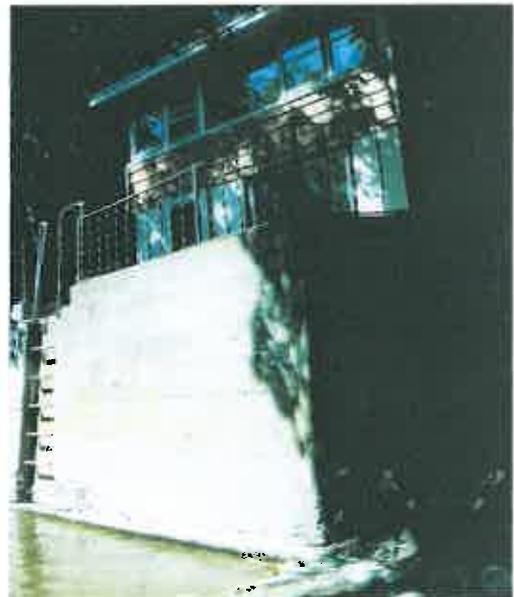
Some homeowners have cleared or mowed their property down to the edge of the river. The riparian zone was seriously compromised in this area. Dumping was also observed, including large items like abandoned cars.

Waterfront home on the Tenmile

- Educate and regulate ATV users.
- Educate homeowners on importance of riparian zone.

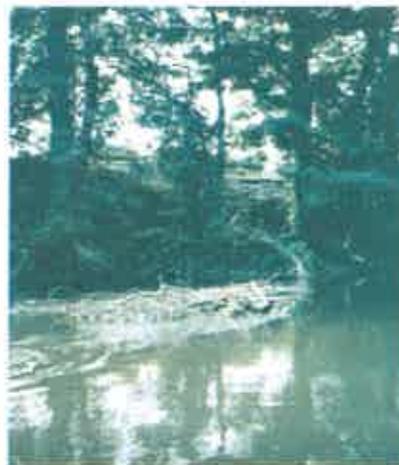
South of J&J Lumber recent clearing and bank instability on the eastern side was observed. The river here is around 60-feet wide with a poor riparian zone. There are unfinished buildings along the riverbank and at one location, a steel cable traverses the river. Also, large numbers of concrete blocks, brush and logs have been dumped onto the banks and into the river. A nearby residential area seems to be contributing trash and garbage as well.

J&J Lumber Mill

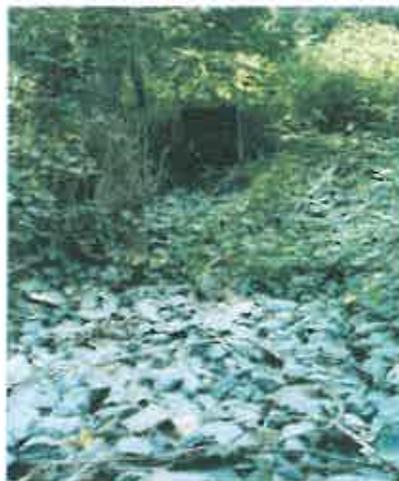
Culvert off of Route 6

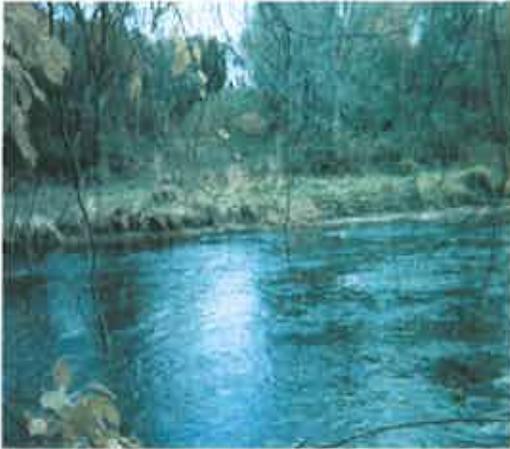
In a few places, homeowners have cut down trees in the riparian zone and have mowed down to the edge of the river. This is a common practice along most of the river and could be remedied by an education program for riparian zone restoration. The cutting is probably to improve the residents' view of the river.

Houses close to the river

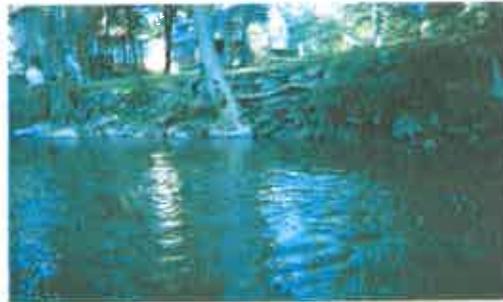
Webatuck Crafts Village

- Work with Crafts Village to restore riparian zone.
- Clean up trash.

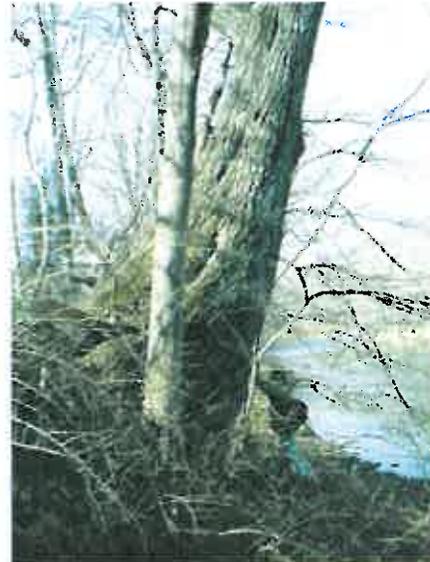
Large oak tree
